Failure identification in composite materials using Thermographics method

R. Amali* and D.T. McLaughlin

Faculty of Environment and Technology, Department of Engineering Design and Mathematics, University of the West of England (UWE), Bristol, BS16 1QY, UK

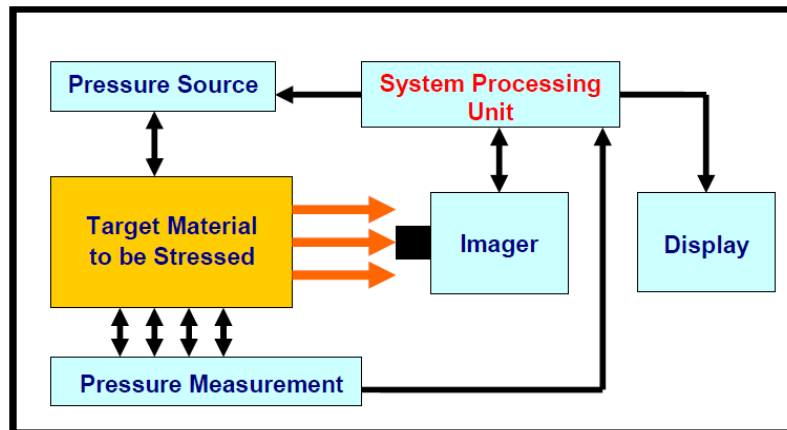
Fig. 1. Example of stress analysis test

Typically during testing a sample is stressed in a cyclic pattern and the resulting thermal pattern is observed via thermal imaging techniques. This cyclic stressing can take form of a sinusoidal pressure change across the specimen's test surface. An example test diagram can be seen in Fig. 1. This type of testing is often used in the evaluation of materials and components during manufacture in the situ stage. During manufacture some components are pre-stressed to increase the components resistance to cracking. During this process the components can weaken leading to early failure of the component.

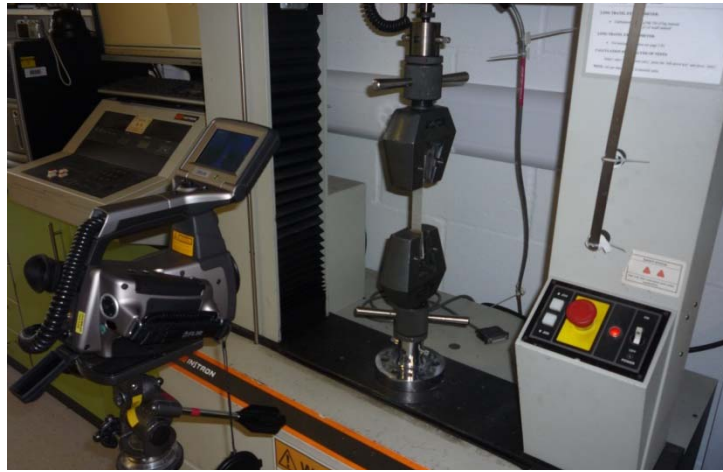
Fig. 2. Experimental setup

From the research into thermographic testing methods it was theorised that a composite part would heat up during failure. A small, uni-directional fibreglass composite samples, of width 20mm, height 80mm and thickness 1mm was strained using an automated tensile testing machine. The samples were tested to full destruction, meaning until it completely split in the horizontal axis, and a thermal camera was used to capture the temperature changes in the samples during their failure. The camera used for the testing was a FLIR system ThermoCAM P25. The testing setup can be seen in Fig. 2. Each sample was strained at a rate of 1mm/minute.

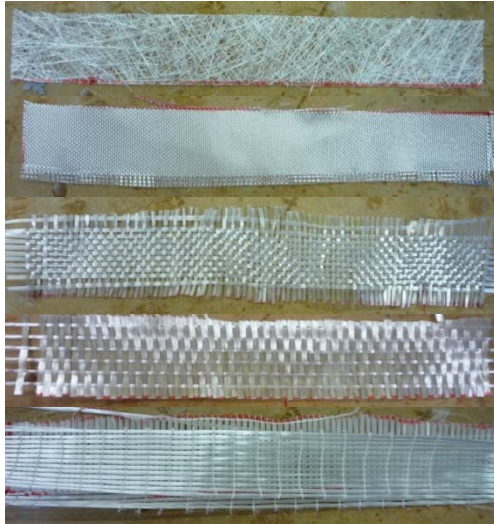
Fig. 4. Sample structure, descending order, sample 1, 2, 3, 4 and 5

The previous test proved that there is indeed a heating induced in a composite sample when failure occurs. However the samples used were identical and simplistic in their structure, being only made from single layer uni-directional fibres. The second set of thermal testing tested five different fibreglass samples of varying internal structure. The differences in the samples are described in Table 1 and the internal structure of the different samples can be seen in Fig. 4. The testing method was exactly the same as previously with the setup seen in Fig. 2.

Sample number	Width (mm)	Height (mm)	Sample characteristics Thickness(mm)	Structure
Sample 1	24	170	0.6	Random cut fiber
Sample 2	25	160	0.6	Fine multi-directional
Sample 3	25	135	1	Medium multi- directional
Sample 4	27	120	1.2	Large multi- directional
Sample 5	26	255	2.3	Triple layer uni-directional

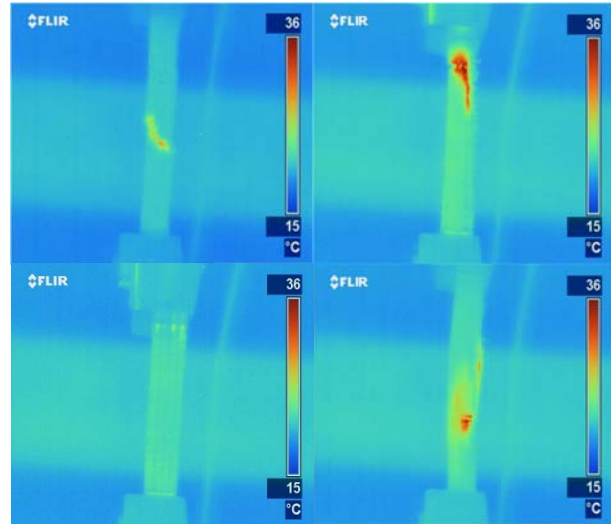
Fig. 5. Testing results, top left: sample 1, top right: sample 3, bottom left: sample 4, bottom right: sample 5

Again, as with the previous thermal testing, thermal emissions were detected from the sample upon failure. Sample 2 did not yield any useable results upon failure however all other samples did. The captured thermal images of said samples can be seen in Fig. 5.

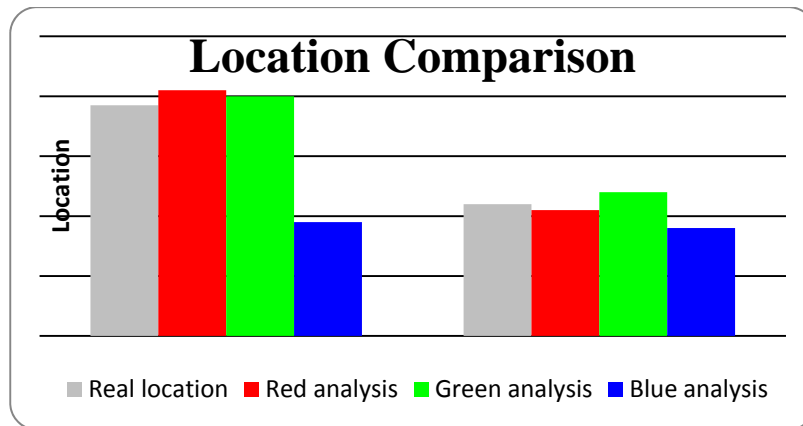
Fig. 7. Location comparison

It was found that the highest value in the red matrix was the location of the failure within the composite structure. To prove the location on the image was correct, the location of defect was physically measured on a printed thermal image. The distances given by both the program and the measured, real image were compared. A graph of this can be seen in Fig. 7. Now knowing that MATLAB[®] provides results equal to that of reality, the program was altered to give the location of the defect as a real world distance on the sample, i.e. the defect location vertically and horizontally from the point of origin (taken as the top left of the sample). This means that the output from the system does not require specialist training to comprehend.
